# THE HISTORICAL DEVELOPMENT OF DATAW ISLAND

## **Section 3 – Architectural Investigations**

**THE HISTORICAL DEVELOPMENT OF  
DATAW ISLAND**

**ARCHITECTURAL AND ARCHAEOLOGICAL INVESTIGATIONS  
AT THE SAMS PLANTATION COMPLEX**

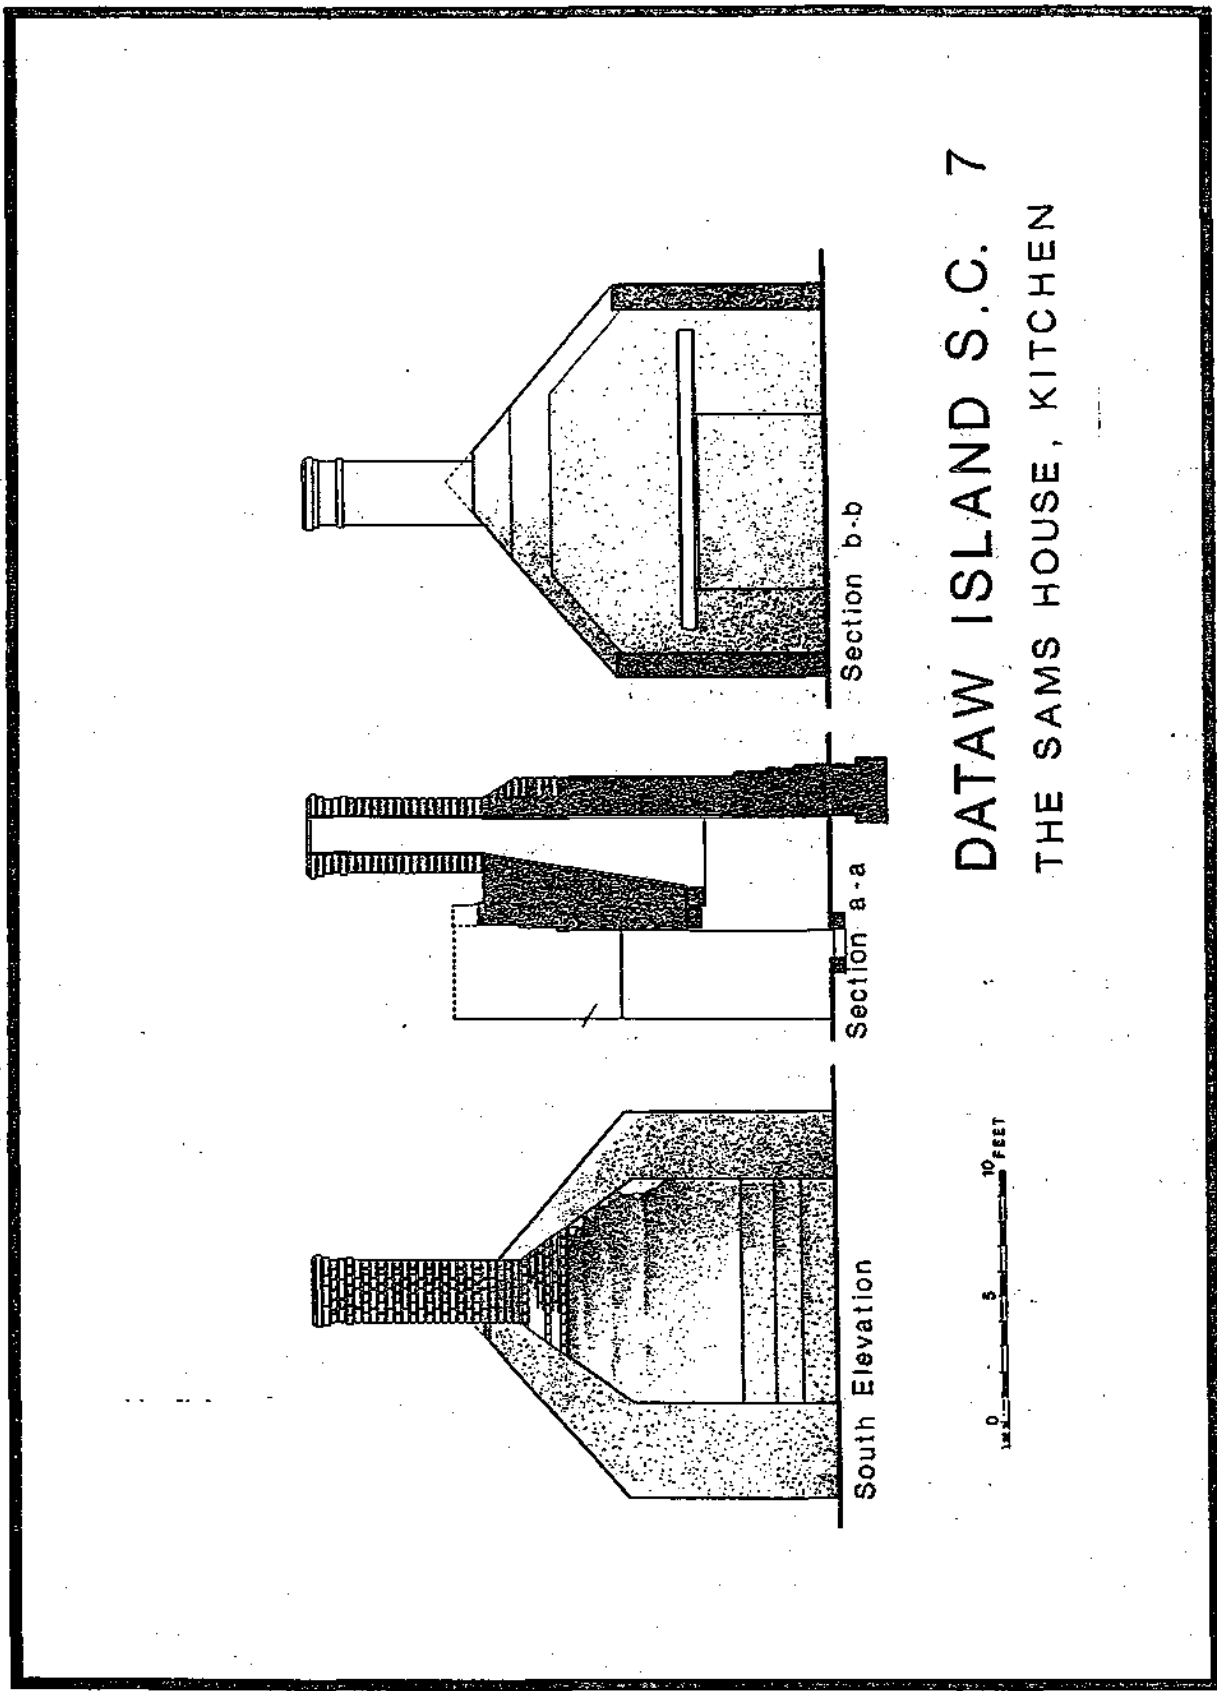
Figure 59. Structure I, The Sams House Kitchen South Elevation and Sections.

DATAW ISLAND S.C. 7  
 THE SAMS HOUSE, KITCHEN

Figure 59 shows the building's south end, still conspicuous since it stands almost intact thanks to massive chimney base construction. Projecting 5 ft 1 in - 5 ft 4 in, the chimney base measures 9 ft 1 in east/west at ground level, and is of a set-back, shouldered form, the tabby shoulders rising as stepped courses rendered smooth with lime mortar. Tabby brick facings form a zone of transition between the base and stack. Stack construction (rising 20 ft 6 in above present grade) utilises tabby brick (repaired, 1983) laid up in English (common) bond; a string course and corbelled cap flanché with shell lime mortar adding distinction to the silhouette. Operational arrangements are more easily seen
