# Brockington

Re: Recent Archaeological Investigations in the Sams Family Cemetery,  
Dataw Island, South Carolina

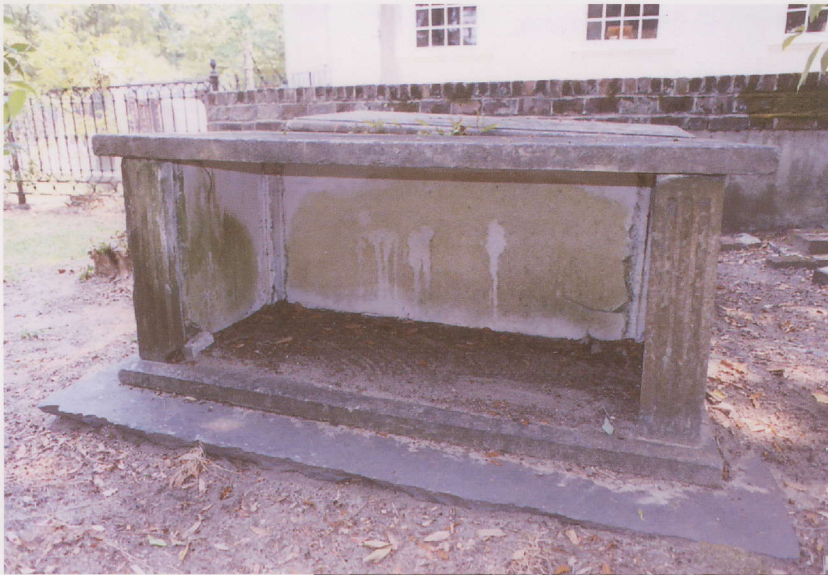
**Crypt at St. Helena Church Cemetery.**

The presumed 1840s sketch shows the panels with oval recessed central areas, very similar to the designs that appear in the panels found in the Sams cemetery today. A very similar structure stands today in the St. Helena Church Yard in Beaufort (see attached photograph). This crypt has been rebuilt with one side wall missing. According to Colin Brooker, local historical architect, such crypts usually did not contain the remains of the interred; they were merely decorative structures built atop the grave.

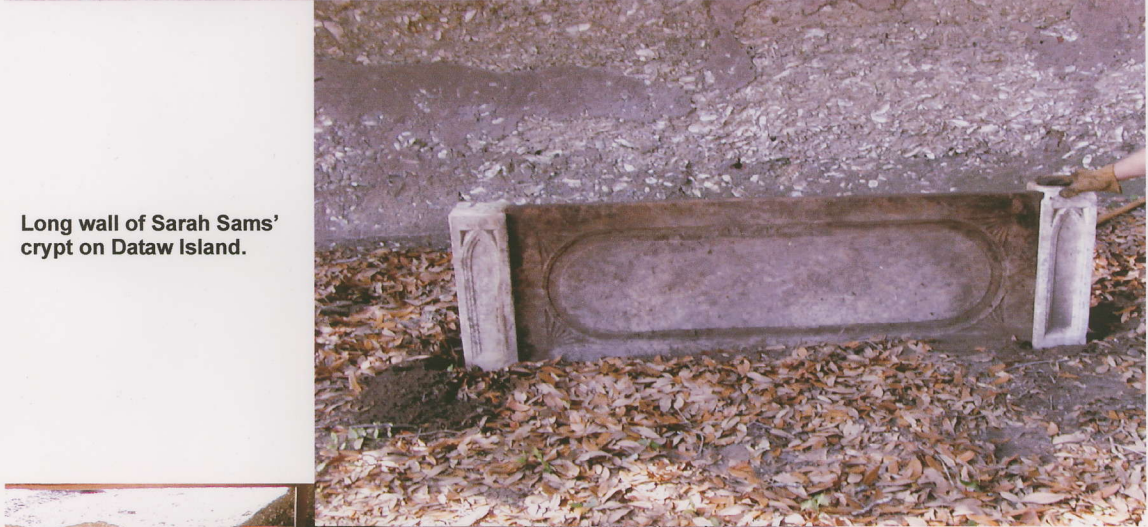
**Long wall of Sarah Sams' crypt on Dataw Island.**

The square slab measures approximately 1.8 feet wide by 1.85 feet high and is 0.15 feet thick. The presumed upper surface of the slab has small holes identical to those on the top of the post. If the slab were inserted into the mortice in the post, the holes in the top of each piece could accommodate a U-shaped brass or iron pin that would tie the pieces together. The rectangular slabs are 4.85 feet long, 1.87 feet high, and 0.15 feet thick. The top of each slab also has holes identical to those seen

on the other slab and the posts. The outer surfaces of the slabs all are carved with sunburst patterns in the upper corners and the center portion recessed in an oval configuration. Gothic arches decorate the outer surfaces of the posts. Photographs of these panels are attached.

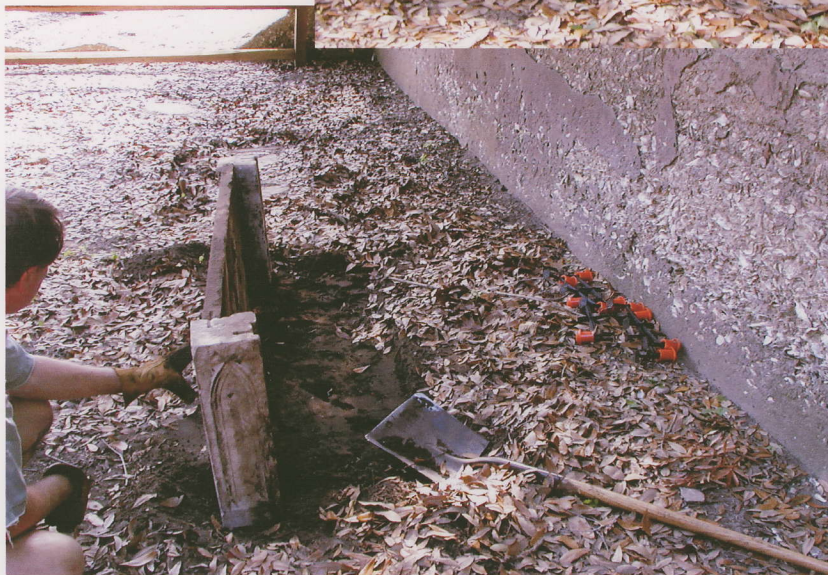
**View along the Sarah Sams' crypt.**

Given the information collected on 21 June 2006, I believe that the marble fragments in the southern portion of the Sams Cemetery are portions of a marble crypt that once stood over the grave of Sarah Sams. There are two side walls, one end wall, and two corner posts. The engraved top marker and the bottom slab remain at rest atop the brick foundation that once supported the entire structure. One of the side walls is broken near the same point where it also is broken on the north edge of the engraved marker. This may indicate an event that resulted in damage to the crypt. Possibly, the walls and corners were removed after this damage, and the engraved slab was then placed directly atop the base slab. Given the similarity of the elements of this crypt to the one in the St. Helena Church Yard, it is unlikely that the remains of Sarah Sams actually were placed within the crypt. Most likely, she was buried in a grave atop which the marble crypt was then erected.

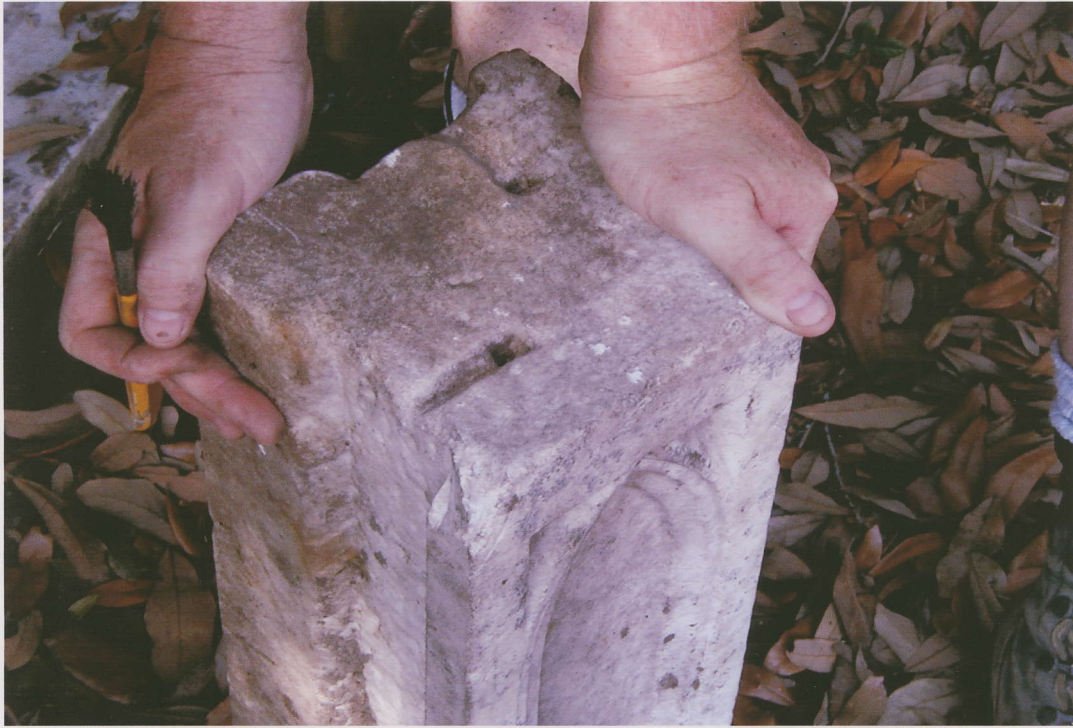
**Pin holes in top of corner post.**

The northeast corner of the marker is broken. Dr. Poplin lifted this fragment and exposed a mortice in the top of the lower slab. The mortice is approximately 0.2 feet from each edge of the slab and extends approximately 0.02 feet into the slab. The entire mortice could not be observed without lifting or moving the engraved marker. The corner was replaced. Dr. Poplin then measured the marble fragments that currently rest near the south wall of the cemetery. The two square "posts" are approximately 0.5 by 0.5 feet and 1.88 feet long. A tenon extends 0.02 feet from the center of the base of each post. Two adjoining sides of each post are carved to create gothic arches. The opposite sides are morticed along the length of the post; the mortices begin approximately 0.1 feet from the finished edge and are approximately 0.22 feet wide and 0.03 feet deep. Small holes are present on the top of each post in line with the mortice.

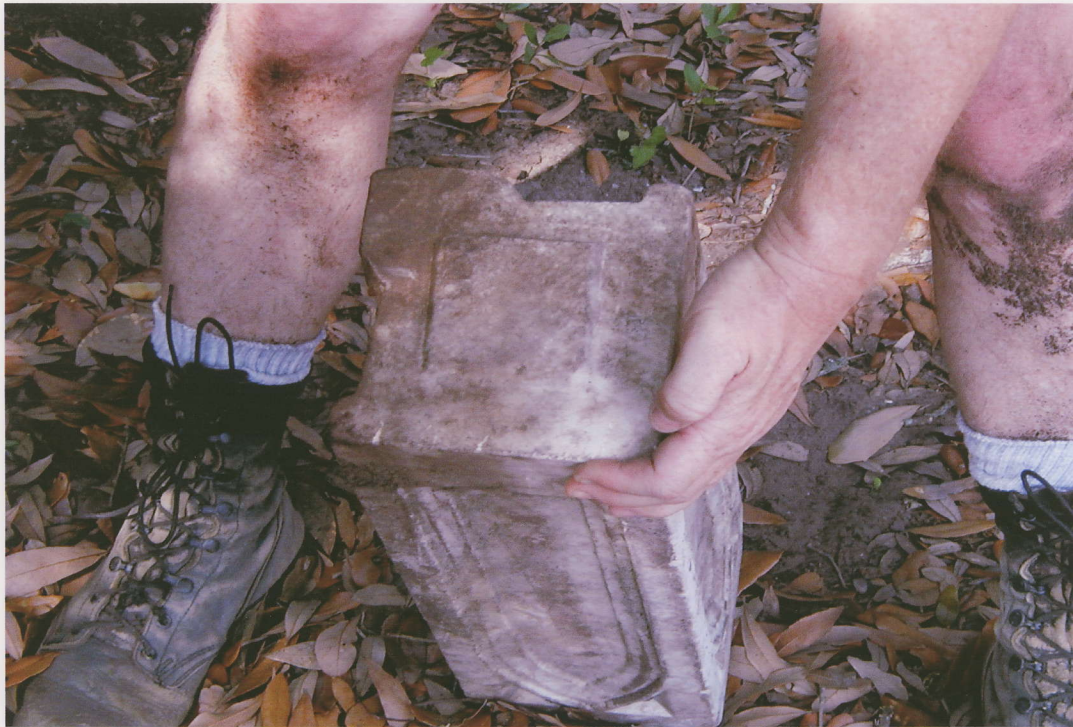
**Tenon on base of corner post.**
